CATERPILLAR 938G

Year	2000
Hours	14463
Weight	13.820 kg
Serial number	6WS02162
Reference	202880

INSPECTION REPORT

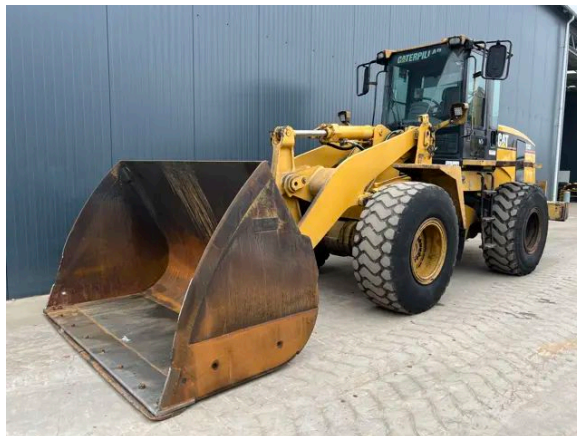
Caterpillar 938G, Engine and model Caterpillar 3126, 108.2 kW, EPA, CE, Air conditioning, Erops cabin, 20.5R25, GP bucket with bolt on edge, Width of the bucket 2.50m, Complete steering wheel, Ride control, Autoshift, Backup alarm, Beacon, Hours certified by Caterpillar, In good and fairly clean condition.
