## VOLVO L220H

| Serial number | VCEL220HC00002983 |

## INSPECTION REPORT

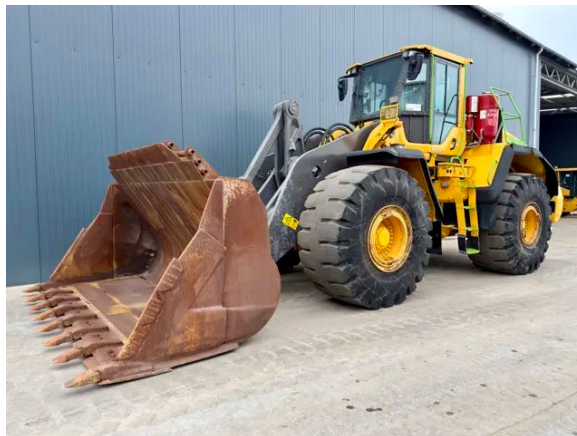
Volvo L220H, Engine and model Volvo D13J, 273 kW, CE, Air conditioning, Erops cabin, 29.5R25 TOYO, GP bucket with teeth, Width of the bucket 3.42m, Complete steering wheel & Joy stick control, Autoshift, Backup camera, Weight load indicator available but not tested, Cental lubrication available but not tested, Immobilizer, Beacon, In very good and very clean condition.
