INSPECTION REPORT

CATERPILLAR CS74

Year	2010
Hours	5028
Weight	15.340 kg
Serial number	CAT0CS74VC8F00426
Reference	210621

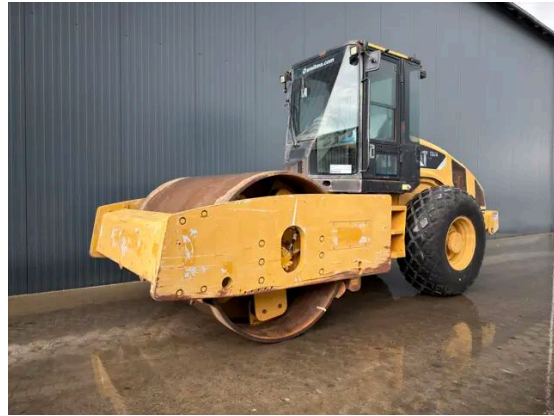
The Caterpillar CS74 is a robust self-propelled roller from 2010, powered by a Caterpillar C6.6 engine. This machine is equipped with an EROPS cabin, backup camera, and alarm system ensuring high safety standards. With only 5028 hours and certification by Caterpillar, it remains in good and clean condition. Featuring 23.1-26 tires, this CS74 provides excellent traction for demanding job sites.
