## INSPECTION REPORT

### VOLVO G946 - AWD

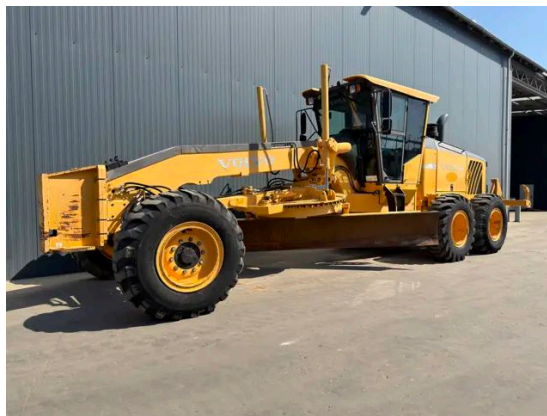
The Volvo G946 - AWD motor grader is a reliable and high-performance machine built in 2011. It is equipped with a powerful Volvo D7E GAE3 engine providing 180 kW, designed to meet EPA standards. This machine includes a push block, ripper, and operates on a 6x6 drive system. The low-profile EROPS cabin features auto shift and hydraulic tip control for enhanced comfort and control. Additional features include a backup camera, differential unlock, AM/FM Radio, and a beacon. The grader's center blade width is 4.27 meters, making it ideal for large-scale operations. This unit is in very good and clean condition, weighing 19,630 kg and measuring 10.77 x 2.78 x 3.24 meters with 7020 run hours.
