INSPECTION REPORT

CATERPILLAR 938M

Year	2015
Hours	12242
Weight	16.200 kg
Serial number	CAT0938MLJ3R00838
Reference	210539

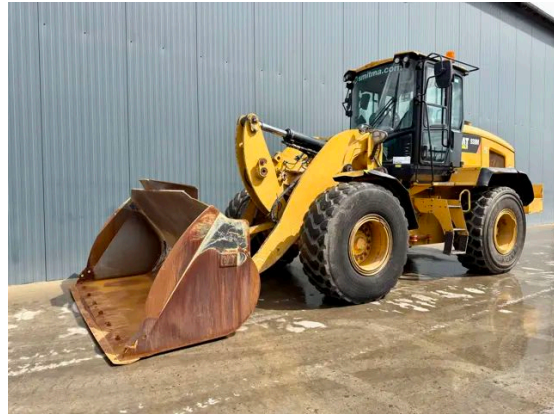
The Caterpillar 938M wheel loader with a Caterpillar C7.1 engine delivering 140 kW, features modern amenities and compliance with EPA and CE standards. It includes an Erops cabin, air conditioning, GP bucket with bolt-on edge, and centralized lubrication. The machine offers innovative features like autoshift, backup camera, and a weight load indicator. Its robust construction ensures a position in very good and clean condition.
