INSPECTION REPORT

CATERPILLAR 140H II - CE

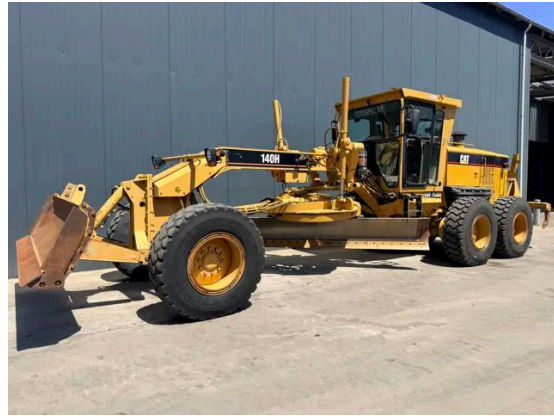
The Caterpillar 140H II is equipped with a Caterpillar 3176 engine delivering 153kW of power. This robust motorgrader features CE certification, a 17.5R25 tire size, a front blade, and a ripper, arranged in a 6x4 configuration. It boasts a low profile EROPS cabin, auto shift capability, and a central blade width of 3.60m. Additional features include central lubrication, differential unlocking, hours certified by Caterpillar, a beacon, and extension options available upon request. The machinery is in very good and clean condition, ready to deliver exceptional performance.
