## INSPECTION REPORT

### VOLVO L60F

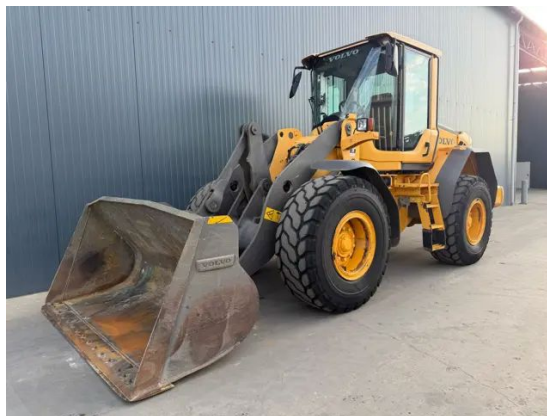
The Volvo L60F is a robust and versatile wheel loader, featuring a powerful 114 kW Volvo D6E LCE3 engine. Equipped with an Erops cabin, this machine ensures operator comfort and protection. It comes with a 20.5R25 tire size and a GP bucket with a bolt-on edge, measuring 2.50 meters in width. Additional features include a complete steering wheel, autoshift, backup camera, alarm, and beacon. With a weight of 13,300 kg and dimensions of 7.35 x 2.50 x 3.22 meters, it is in very good and clean condition, offering reliability for various tasks.
