INSPECTION REPORT

AMMANN ASC130D

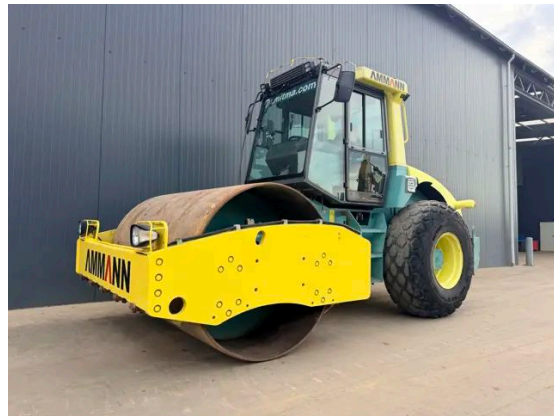
The Ammann ASC130D is a self-propelled roller powered by a Cummins QSB 4.5 engine with 119 kW. This 2007 model includes an EROPS cabin, EPA and CE certifications, and is equipped with an AM/FM radio. The machine weighs 12,630 kg and has dimensions of 5.55 x 2.45 x 3.10m. It has genuine hours and is in good, clean condition, ideal for heavy-duty applications.
