CATERPILLAR 735B

Year	2013
Hours	16568
Weight	32.000 kg
Serial number	CAT0735BPT4P00409
Reference	202785

INSPECTION REPORT

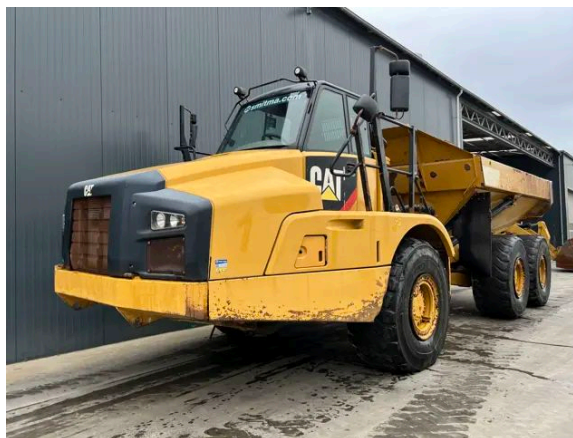
Caterpillar 735B, Engine Caterpillar , C15, 333 kW, Air conditioning, 6x6, Erops cabin, 26.5R25, Retarder, Backup camera, Backup alarm, Central lubrication, Beacon, AM/FM radio, Hours certified by Caterpillar, In good and clean condition.
