INSPECTION REPORT

CATERPILLAR 140M2

Year	2011
Hours	12363
Weight	19800 kg
Serial number	CAT0140MTM9D00582
Reference	211795

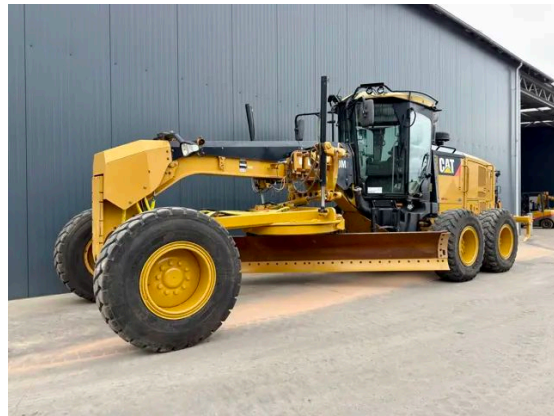
The Caterpillar 140M2 is a robust and efficient motor grader designed for high performance and durability. Featuring a powerful Caterpillar C9 engine with 182 kW output and EPA compliance, this machine is ideal for complex grading tasks. It offers a 6x4 drive with auto shift, hydraulic tip control, and a center blade width of 4.27m. Additional features include blade lift accumulators, differential unlock, an AM/FM radio, and hours certified by Caterpillar. With a weight of 19800 kg and dimensions of 9.65x2.75x3.36m, it ensures stability and efficiency. The machine, produced in 2011, has recorded 12363 hours and is in very good, clean condition.
