CATERPILLAR CS76 XT

INSPECTION REPORT

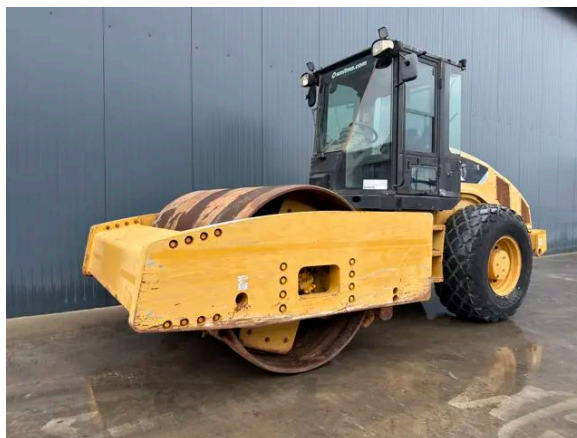
Caterpillar CS76 XT, Caterpillar, C6.6, 129.5 kW, CE, Erops cabin, 23.1-26, Air conditioning, Backup alarm, Hours certified by Caterpillar, In very good and fairly clean condition.
