CATERPILLAR CS76 XT

INSPECTION REPORT

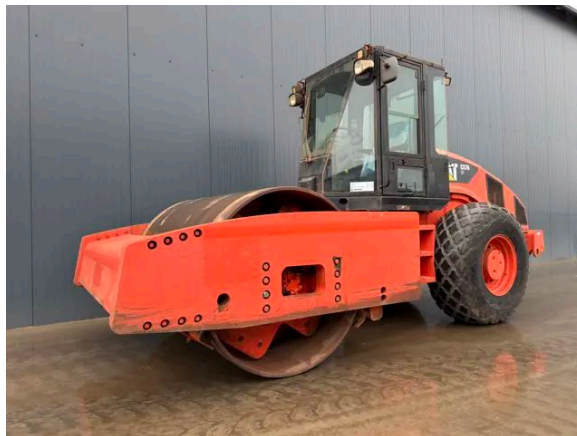
Caterpillar CS76 XT, Caterpillar , C6.6, 129.5 kW, EPA, CE, Erops cabin, 23.1-26, Air conditioning, Backup alarm, Beacon, Hours certified by Caterpillar, In very good and clean condition.
