INSPECTION REPORT

CATERPILLAR 140M3

Year	2015
Hours	8556
Weight	20.000 kg
Serial number	CAT0140MEN9M00208
Reference	210676

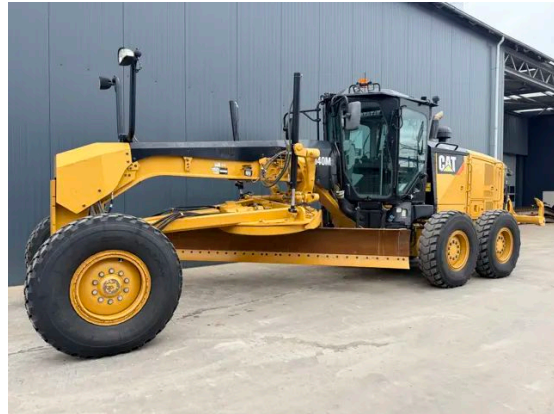
The Caterpillar 140M3 is a high-performance motor grader, equipped with a robust Caterpillar C9.3 engine delivering 189 kW of power. Manufactured in 2015, this machine is in excellent condition with a wide range of features such as air conditioning, a ripper, a low-profile EROPS cabin with auto shift, and a 6x4 drive. It has a central blade width of 4.28m, blade lift accumulators, central lubrication, a backup camera, and a differential unlock system. This motor grader provides great reliability and efficiency for demanding jobs. The engine hours are certified by Caterpillar, ensuring its trustworthy operation.
