AMMANN ASC130 D

Year	2009
Hours	6767
Weight	12.630 kg
Serial number	107228/0104
Reference	208119

INSPECTION REPORT

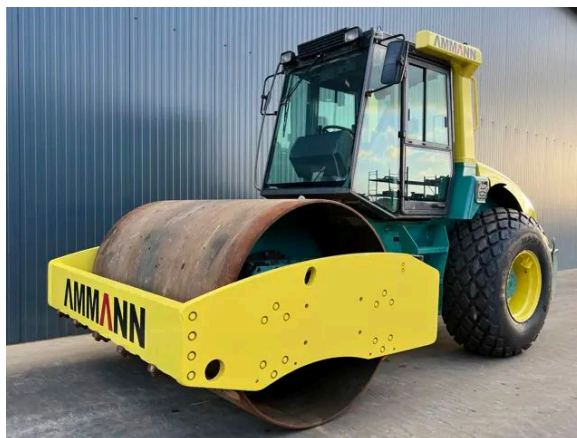
Ammann ASC130 D, Cummins , QSB4.5, 119 kW, EPA, CE, Erops cabin, 23.1-26 NEW!, Air conditioning, Backup alarm, In very good and very clean condition.
