INSPECTION REPORT

LIEBHERR L550 Xpower

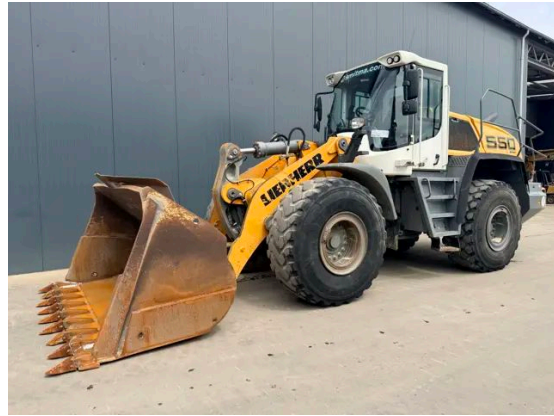
The LIEBHERR L550 X-Power is a robust and advanced wheel loader, featuring a D934 A7-04 engine with 140kW power. This machine, manufactured in 2016 in Austria, complies with CE standards and has an emission level of Stage IV. It includes a comfortable EROPS cabin with air conditioning, 23.5R25 tires, a general-purpose bucket with teeth (2.70m wide), a complete steering wheel, and a variety of safety and convenience features such as a backup camera and alarm, central lubrication, and AM/FM radio. It has 10,845 genuine operating hours and is in excellent condition.
