## INSPECTION REPORT

### AMMANN ASC110 HX

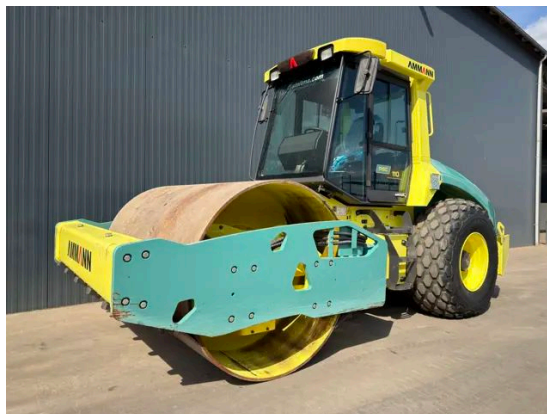
The Ammann ASC 110 HX is a reliable self-propelled roller featuring a Deutz TCD 4.1 L4 engine delivering 115 kW of power. Equipped with an EROPS cabin, CE and EPA compliance, and a backup alarm, this machine is in excellent condition. With only 443 operational hours, it combines robust construction with efficiency—perfect for demanding environments.

| Overall condition | In very good and very clean condition. |
