CATERPILLAR 735

Year	2006
Hours	15945
Weight	32.400 kg
Serial number	CAT00735PB1N00686
Reference	204080

INSPECTION REPORT

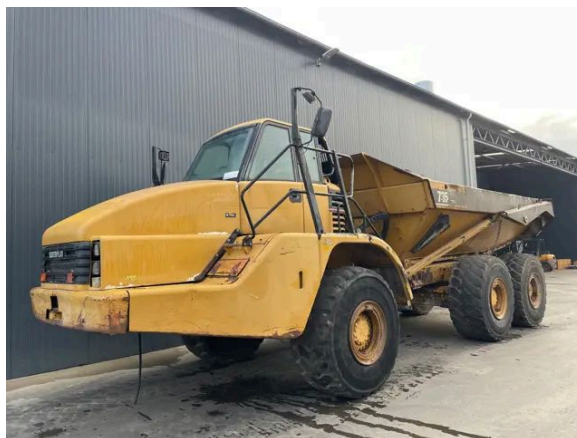
Caterpillar 735, Engine Caterpillar , C15, Air conditioning, 6x6, Erops cabin, 26.5R25, Retarder, Heated body, Big tailgate, Backup alarm, Central lubrication, Hours certified by Caterpillar, In good and clean condition.
