## INSPECTION REPORT

### DYNAPAC CA512D

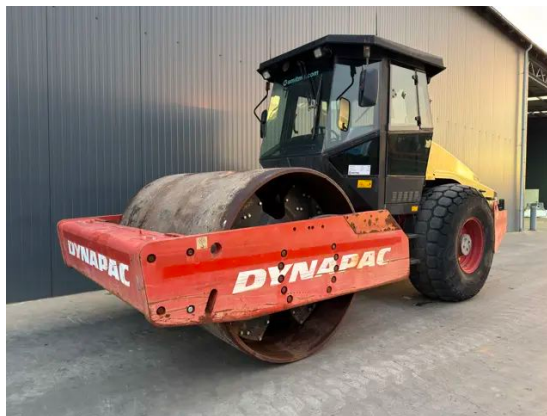
The Dynapac CA512D is a robust self-propelled roller from 2008, featuring a Cummins QSB6.7 engine with 129 kW power. This machine includes an EROPS cabin, air conditioning, backup alarm, beacon, and fast fuel system. It is equipped with 23.1-26 tires and an AM/FM radio. Weighing 15,650 kg and measuring 6.05 x 2.36 x 3.00 meters, it is in good and clean condition with 5102 running hours.
