## INSPECTION REPORT

### BOMAG BW161AD-5

Year	2016
Hours	2954
Weight	10370 kg
Serial number	101921401080
Reference	213598

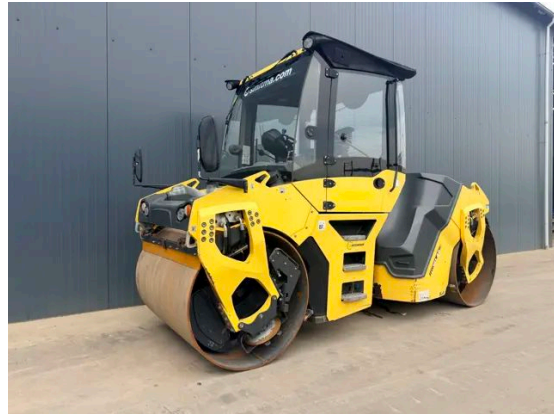
The Bomag BW161 AD-5 is a high-performance vibrating roller equipped with a Kubota V3800 engine, delivering 83.5 kW of power. With a drum width of 1.67 meters, it meets Tier 4 emission standards and is EPA certified. This model features an EROPS cabin for comfortable operation, a water sprinkler system, dual vibrating drums, and a cutting edge. Additional amenities include an AM/FM radio, genuine working hours, and it is in excellent condition.
