CATERPILLAR 336F LN

Year	2015
Hours	13067
Weight	36.830 kg
Serial number	CAT0336FKRBC00210
Reference	209069

INSPECTION REPORT

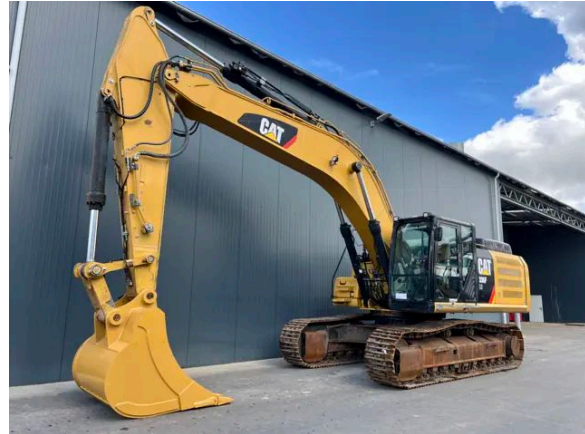
Caterpillar 336FLN, Engine brand and model Caterpillar C9.3, 236 kW, EPA, but sticker not available, CE, Air conditioning, Central lubrication, Backup camera, Cat walk, Width of the pads 600mm, Mono boom, Length of the mono boom 6.50m, Length of the stick 3.20m, New digging bucket with teeth, Width of the bucket 1.53m, Piped for hammer, Burst valve on lift and stick cylinder, AM/FM Radio, Hours certified by Caterpillar, In very good and very clean condition.
