## INSPECTION REPORT

### KOMATSU WA470-8 - Joystick Steering

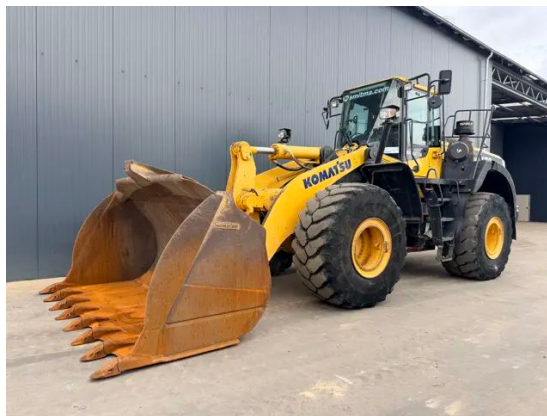
The Komatsu WA470-8 wheel loader, manufactured in Japan in 2018, is equipped with a 204kW Komatsu SAA6D125E-7 engine. It features an Erops cabin, air conditioning, a central lubrication system, and a GP bucket with teeth measuring 3.10m wide. With genuine hours of operation, it includes enhanced safety and operational features such as a backup camera, alarm, AM/FM radio, and Autoshift functionality. This wheel loader is in very good and clean condition, weighs 26,750 kg, and offers a spacious interior with modern amenities.
