## CATERPILLAR D6N LGP

# INSPECTION REPORT

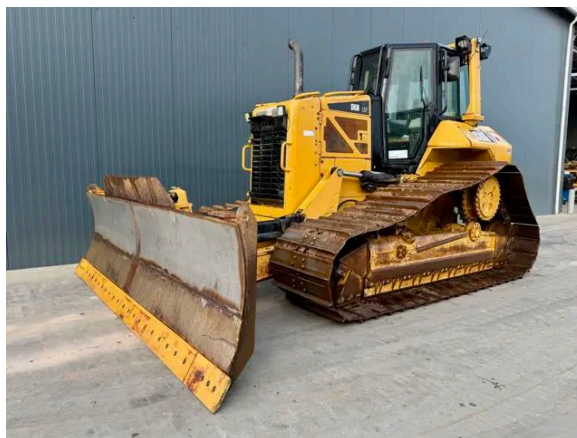
Caterpillar D6N LGP, Engine brand Caterpillar, C6.6, 129 kW, EPA, Air conditioning, Erops cabin, 6-way blade, Width of the blade 4.05m, Differential steering, Width of the pads 860mm, Draw bar, Backup camera, Beacon, New ripper available, ask for quotation, Hours certified by Caterpillar, In good and clean condition.
