## INSPECTION REPORT

### CATERPILLAR 12H - CE

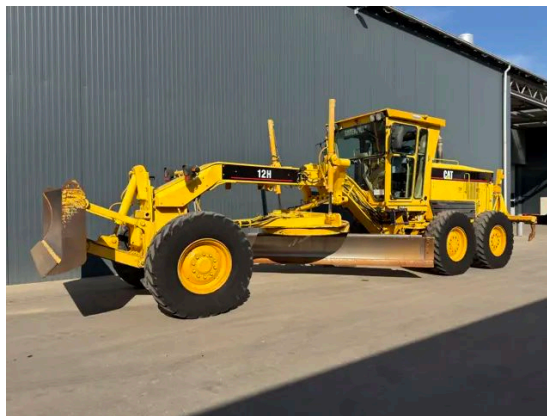
The Caterpillar 12H - CE is a robust motor grader designed for excellent performance in a wide range of applications. Equipped with a powerful Caterpillar C-9 engine that delivers 123 kW, this machine ensures efficient and reliable operation. It features a low-profile EROPS cabin, automatic shift, and hydraulic tip control for enhanced comfort and control. The grader is equipped with a front blade and ripper, functions in a 6x4 configuration, and includes a backup camera for safety. Additionally, it has differential unlock capability and its hours are certified by Caterpillar, ensuring dependable performance.

| Overall condition | In good and very clean condition. |
