CATERPILLAR 315F LCR

INSPECTION REPORT

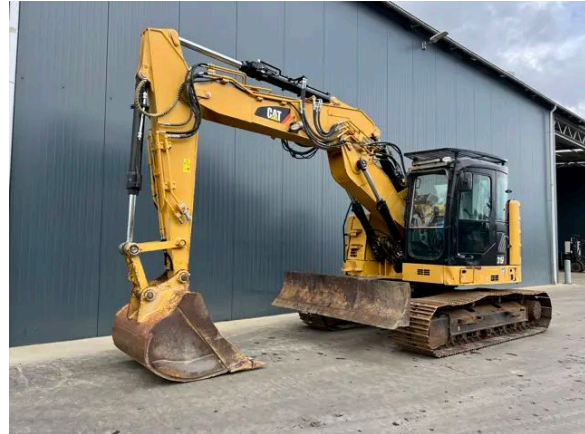
Caterpillar 315FLCR, Engine brand and model Caterpillar C4.4, 74.4 kW, CE, Air conditioning, Backup camera, Cabin protection, Width of the pads 600mm, V/A boom, Length of the stick 2.10m, Digging bucket with teeth, Piped for hammer & shear, Burst valve on lift, V/A and stick cylinder, Hours certified by Caterpillar, In good and clean condition.

Year	2017
Hours	9516
Weight	15.500 kg
Serial number	CAT0315FTTDY10779
Reference	208572
