CATERPILLAR 323EL VA

Year	2012
Hours	12341
Weight	22700
Serial number	CAT0323ETRAP00339
Reference	211931

INSPECTION REPORT

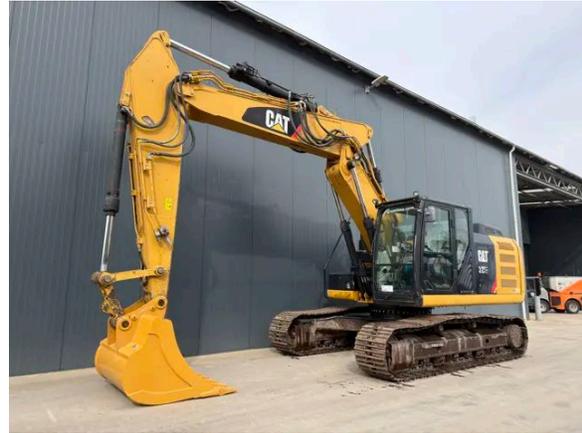
Caterpillar 323EL VA, Engine brand and model Caterpillar C6.6, 122 kW, EPA, CE, Air conditioning, Backup camera, Width of the pads 600mm, V/A boom, Length of the stick 2.90m, New digging bucket with teeth, Width of the bucket 1.40m, Piped for hammer, shear and clamp, Burst valve on lift, V/A and stick cylinder, AM/FM Radio, Hours certified by Caterpillar, In good and clean condition.
