## INSPECTION REPORT

### VOLVO L150E

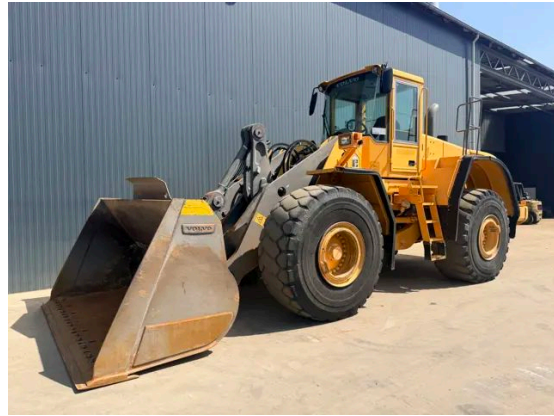
The Volvo L150E is a robust wheel loader engineered for heavy-duty tasks. Powered by the D9A engine producing 186kW, it adheres to EPA standards and offers a range of premium features. This 2005 model boasts an EROPS cabin with air conditioning, making it ideal for various climates. The machine includes a GP bucket with a bolt-on edge, measuring 2.95 meters wide. Enhanced maneuverability is provided by a complete steering wheel and advanced ride control. Additional features such as autoshift, central lubrication, and a functional AM/FM radio enhance operability. Weighing 26,100 kg, the loader demonstrates genuine hours and is maintained in excellent, clean condition.
