## INSPECTION REPORT

### CATERPILLAR 320E L

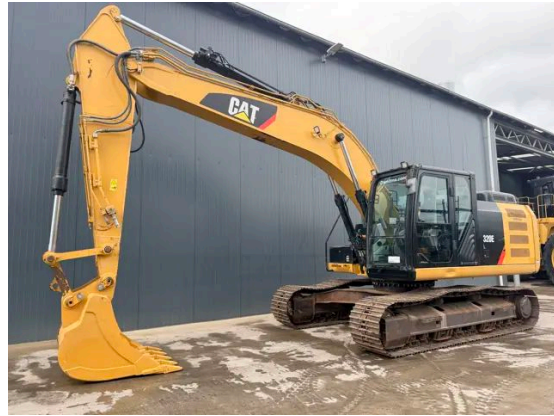
The Caterpillar 320E L is a robust and reliable excavator, powered by the Caterpillar C6.6 engine with a capacity of 122kW. Equipped with EPA and CE certifications, it ensures both safety and environmental compliance. This machine features air conditioning, central lubrication, and a backup camera for enhanced operation in various conditions. Additional features include a mono boom of 5.70m, a stick of 2.95m, and a new digging bucket with teeth measuring 1.20m wide. With piping for hammer and shear and a burst valve on lift and stick cylinder, this excavator is built for efficiency. In good and clean condition, it has 10,148 operational hours certified by Caterpillar.
