## CATERPILLAR 963K

Year	2016
Hours	7024
Weight	21570 kg
Serial number	CAT0963KJLBL00315
Reference	210942

# INSPECTION REPORT

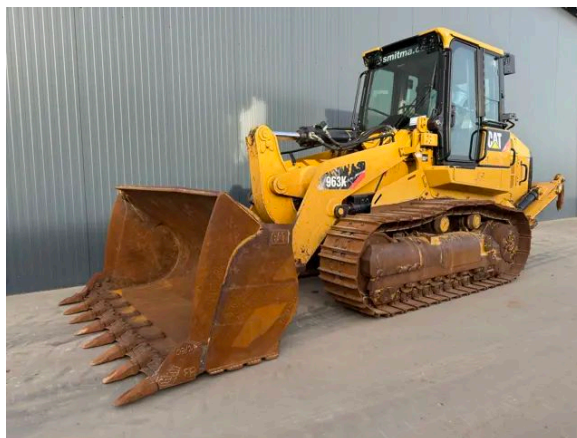
Caterpillar 963K, Engine Caterpillar, C7.1, 164.9 kW, EPA, CE, Air conditioning, Erops cabin, GP bucket with teeth, Width of the bucket 2.68m, Backup camera, Backup alarm, AM/FM radio, Hours certified by Caterpillar, In very good and very clean condition.
