CATERPILLAR 374FL ME | U/C 70%!

Year	2014
Hours	15169
Weight	73.100 kg
Serial number	CAT0374FLDNM00249
Reference	207855

INSPECTION REPORT

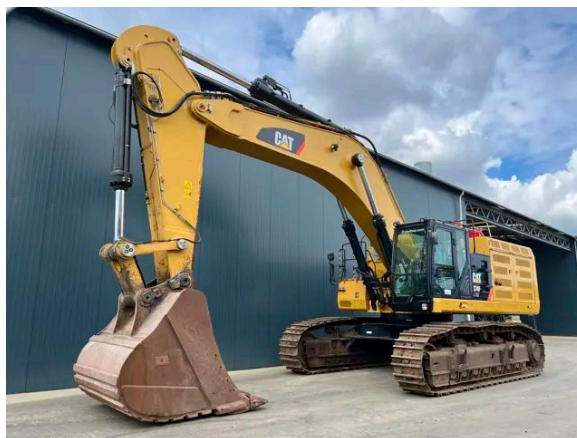
Caterpillar 374FLME, Engine brand and model Caterpillar C15, 362 kW, EPA, CE, Air conditioning, Central lubrication, Backup camera, Backup alarm, Beacon, Width of the pads 655mm, Mono boom, Length of the mono boom 7.00m, Length of the stick 3.00m, Digging bucket with teeth, Width of the bucket 2.02m, Burst valve on lift and stick cylinder, Retractable undercarriage, AM/FM Radio, Hours certified by Caterpillar, In very good and very clean condition.
