## INSPECTION REPORT

### CATERPILLAR 966M

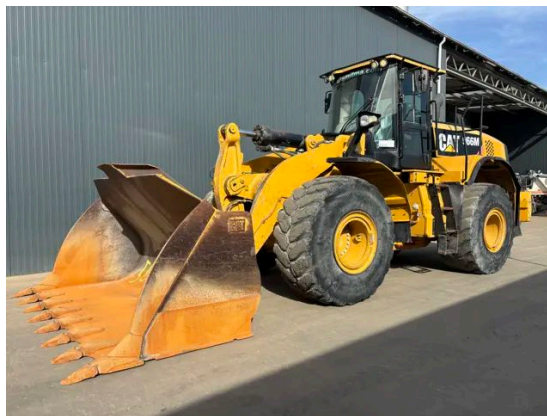
The Caterpillar 966M is a robust and efficient wheel loader, featuring a powerful C9.3 engine delivering 229kW. This model is EPA and CE certified, ensuring high environmental and safety standards. It comes with a comfortable Erops cabin equipped with air conditioning and an AM/FM radio. Its GP bucket with teeth measures 3.20m in width, ideal for heavy-duty operations. It also boasts advanced features such as joystick control, ride control, autoshift, and a backup camera. With central lubrication, certified working hours, and a clean and excellent condition, this machine is ready to deliver exceptional performance on the job site.
