INSPECTION REPORT

CATERPILLAR M315F

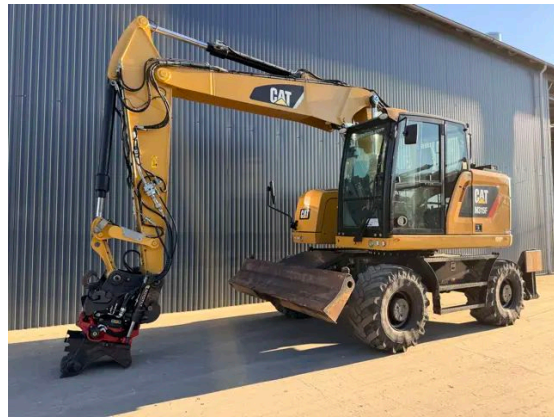
The Caterpillar M315F is a high-performance wheel excavator, designed to meet the demands of modern construction projects. Equipped with a robust Caterpillar C4.4 engine, delivering 117 kW of power, and compliant with Stage IV emissions standards, this machine ensures both efficiency and environmental responsibility. Key features include air conditioning, central lubrication, a backup camera, and hydraulic quick release. The M315F is piped for hammer, shear, and clamp applications, and it boasts a burst valve on the lift and V/A cylinder. With a weight of 17,500 kg and dimensions of 8.20 x 2.55 x 3.27 m, it provides stability and power, making it ideal for various tasks. Certified hours and impeccable maintenance record ensure reliability.

| Overall condition | In very good and very clean condition. |
