## INSPECTION REPORT

# CATERPILLAR D8T - CE Document And TA2 Inspection Available

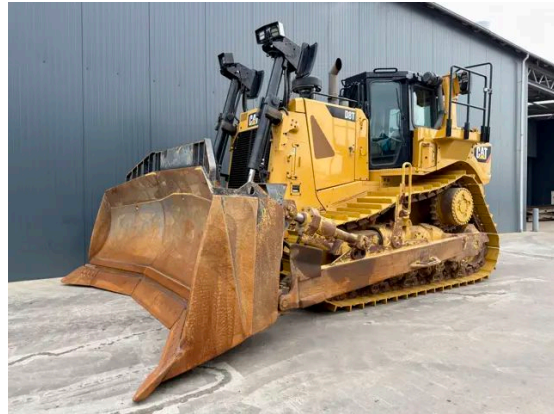
The Caterpillar D8T is a powerful dozing machine designed for efficiency and durability. Powered by a Caterpillar C15 engine with 248 kW power, it meets EPA and CE requirements. Features include air conditioning, an Erops cabin, a straight tilt blade with a width of 4.25m, and differential steering. It also includes a single shank ripper, hydraulic pin puller, and a fast fuel system. The machine is in excellent and clean condition with 11,451 operating hours certified by Caterpillar, and a CAT TA2 report available.
