DOOSAN DX170W

INSPECTION REPORT

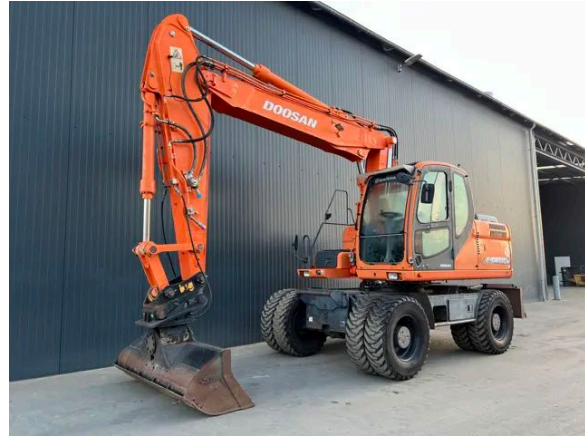
Doosan DX170W, Engine brand Doosan , DL06, 104 kW, EPA, CE, Air conditioning, Backup camera, Tyre size 315/80 R22.5, V/A boom, Length of the stick 2.50m, Hydraulic quick release, Hydraulic angling ditch cleaning bucket, Width of the bucket 2.00m, Piped for hammer, shear and clamp, Burst valve on lift, V/A and stick cylinder, AM/FM radio, In very good and very clean condition.
