## INSPECTION REPORT

### CATERPILLAR M315F - With OilQuick

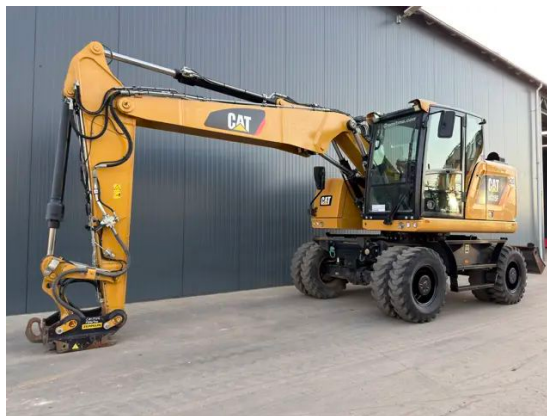
The Caterpillar M315F is a highly efficient wheeled excavator ideal for varied operations. Manufactured in 2017 and powered by a robust Caterpillar C4.4 engine delivering 117 kW. Featuring an EPA-certified engine, CE certification, air conditioning, central lubrication, and a backup camera for enhanced operation comfort. This model includes a V/A boom, a 2.30m stick, and a hydraulic quick release with OilQuick. It's piped for hammer & shear and fitted with burst valves on its lift, V/A, and stick cylinder. With 9940 working hours, this unit is in excellent condition.
