## CATERPILLAR 980M - DUTCH MACHINE

# INSPECTION REPORT

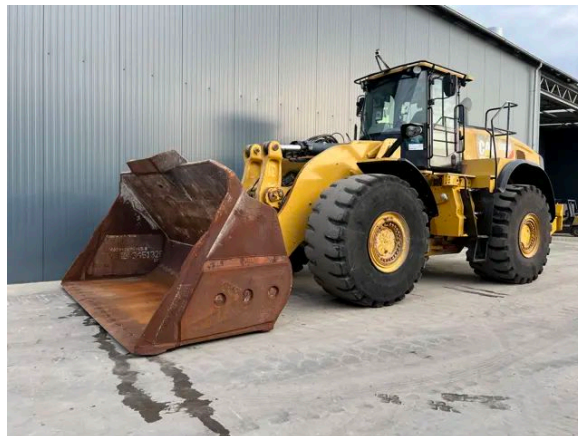
Caterpillar 980M, Engine and model Caterpillar C13, 313 kW, CE, Air conditioning, Erops cabin, 29.5R25, GP bucket with bolt on edge, Width of the bucket 3.59m, Joy stick control, Ride control, Autoshift, Backup camera, Backup alarm, Weight load indicator available but not tested, Cental lubrication available but not tested, Beacon, AM/ FM radio, Hours certified by Caterpillar, In very good and very clean condition.
