VOLVO EC750E L

Year	2018
Hours	13111
Weight	78000
Serial number	VCEC750EK00310135
Reference	206303

INSPECTION REPORT

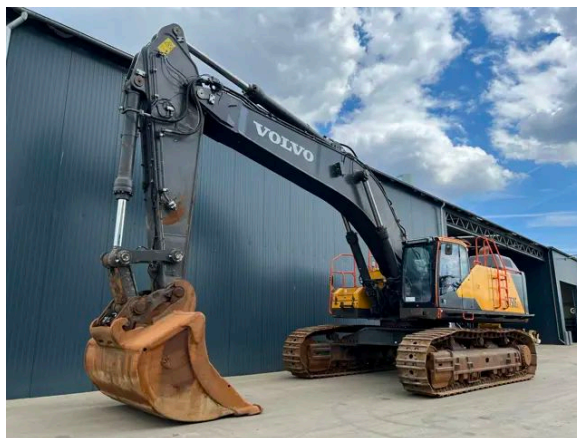
Volvo EC750EL, Engine brand and model Volvo D16J, 385 kW, CE, Air conditioning, Central lubrication, Backup camera, Beacon, Fast fuel system, Cat walk, Width of the pads 650mm, Mono boom, Length of the mono boom 7.70m (25.3ft), Length of the stick 3.55m (11.8ft), Hydraulic quick release, Digging bucket with teeth, Width of the bucket 2.22m, Piped for hammer, Burst valve on lift and stick cylinder, Retractable undercarriage, AM/FM Radio, In very good and very clean condition.
