## CATERPILLAR 320D L

Year	2009
Hours	12071
Weight	24.300 kg
Serial number	CAT0320DHGDP00134
Reference	208181

# INSPECTION REPORT

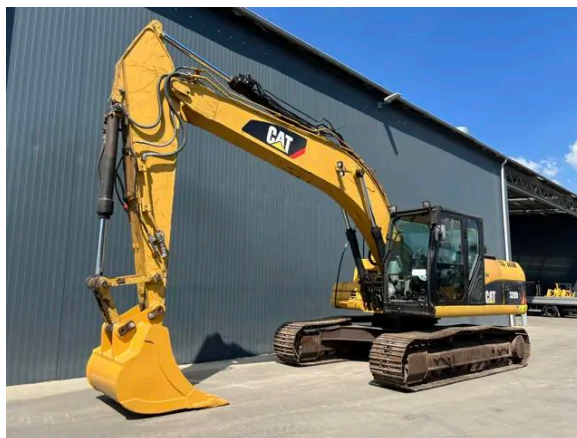
Caterpillar 320D L, Engine brand and model Caterpillar C6.4, 110 kW, CE, Air conditioning, Backup camera, Width of the pads 600mm, Mono boom, Length of the mono boom 5.70m, Length of the stick 2.90m, New digging bucket with teeth, Width of the bucket 1.40m, Piped for hammer, shear and clamp, Burst valve on lift and stick cylinder, Hours certified by Caterpillar, In good and clean condition.
