SMITMA
HEAVY EQUIPMENT

INSPECTION REPORT

CATERPILLAR 120M

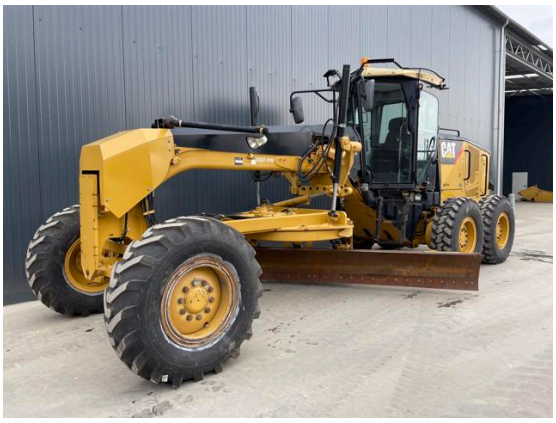
The Caterpillar 120M is a reliable motor grader equipped with a powerful Caterpillar C6.6 engine. This model includes air conditioning and features new 14.00 R24 front tires. With a 6x4 drive, it offers precise hydraulic tip control and a wide center blade width of 4.29 meters. It features differential unlock and the operational hours are certified by Caterpillar. Extensions are available upon request. This machine is in very good and highly clean condition.
