INSPECTION REPORT

CATERPILLAR 730C2

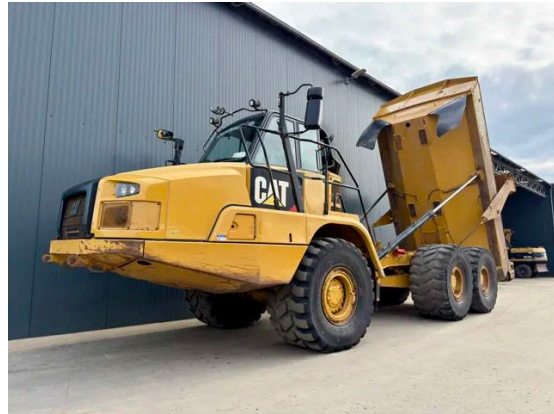
The Caterpillar 730C2 is a robust articulated dumper with a powerful Caterpillar C13 engine generating 276 kW. This model features a 6x6 drive and an EROPS cabin, designed for superior performance in tough environments. With a large tailgate, backup camera, and retarder, it ensures efficient and safe operation. Additional features include air conditioning, backup alarm, central lubrication, and a beacon. The vehicle is equipped with GOODYEAR 750/65R25 tires at 70% tread. Certified hours and a condition report confirm its very good and clean state.
