DYNAPAC CA152D

Description

INSPECTION REPORT

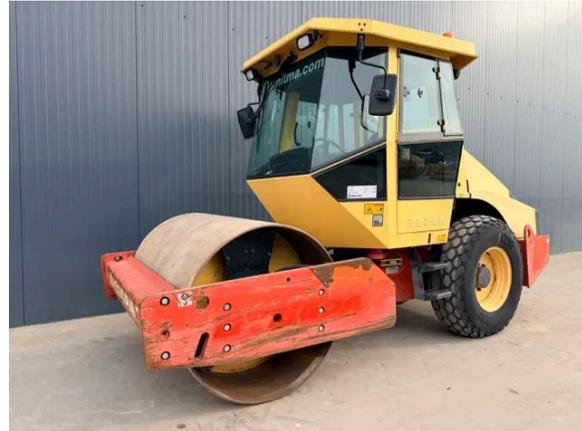
Dynapac CA 152D, Cummins, QSB 3.3, 74kW, EPA, CE, Erops cabin, 14.9 - 24, Compaction meter, Frequency meter, Air conditioning, Beacon, AM/FM radio, Genuine hours, In good and very clean condition.
