## INSPECTION REPORT

### BELL B25E

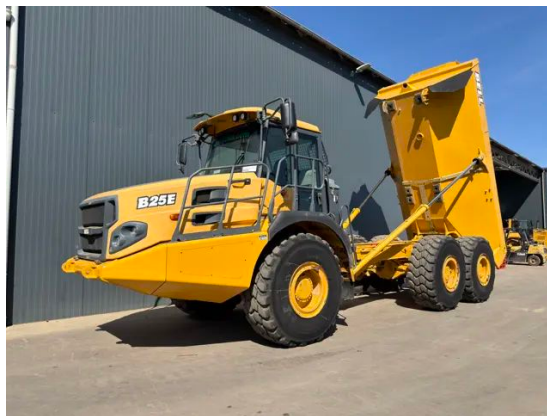
The Bell B25E Articulated Dumper is equipped with a powerful Mercedes OM926LA engine producing 210 kW of power. This 6x6 machine is built with an EROPS cabin for safety and comfort. It features CE certification, an air conditioning system, and comes with Michelin 23.5R25 tires. Additional features include a retarder, backup camera, and a weight load indicator. In excellent condition, this machine has been well-maintained to ensure reliability and efficiency for demanding work environments.
