## CATERPILLAR 140M3 AWD

### Description

# INSPECTION REPORT

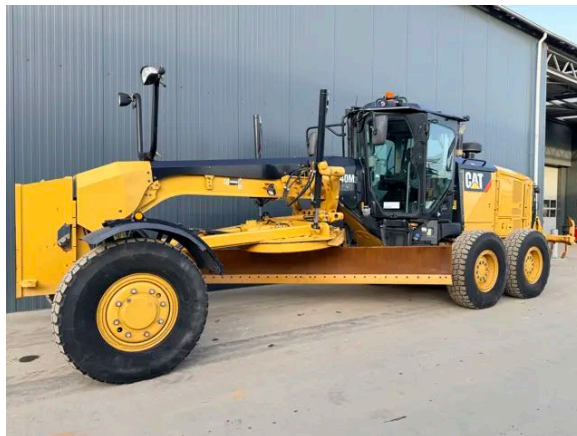
Caterpillar 140M3 AWD, Engine and model Caterpillar C9.3, 189kW, EPA, Air conditioning, 14.00R24, Push block, 6x6, High profile erops cabin, Width of the center blade 4,25m, Differential unlock, AM/FM Radio, Hours certified by Caterpillar, Beacon, Extensions available, ask for quotation, In very good and clean condition.
