INSPECTION REPORT

CATERPILLAR 950M

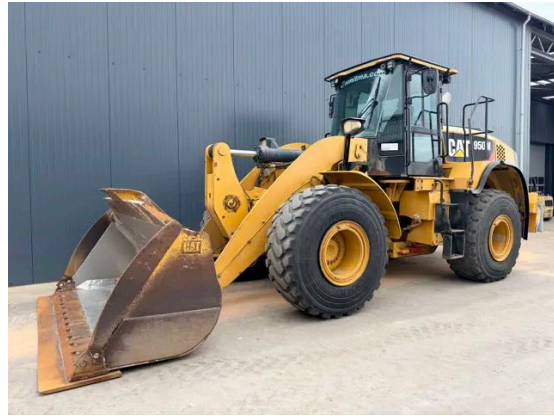
The Caterpillar 950M wheel loader, equipped with a Caterpillar C7.1 engine and an output of 200kW, is designed for efficiency and reliability. It features emissions compliance with EPA and CE standards, and a Step 4 Final emission level. The machine comes with an EROPS cabin, ensuring operator comfort. Fitted with Michelin 23.5R25 tires, and a GP bucket with a welded edge, offering a width of 2.90m. The wheel loader also includes a complete steering wheel, ride control, autoshift functionality, and a backup camera. Additional features include a weight load indicator, central lubrication, beacon, and AM/FM radio. Certified hours by Caterpillar assure its quality, with a current total of 12207 hours. This machine, manufactured in 2015, remains in good and clean condition.
