## INSPECTION REPORT

### VOLVO A25E

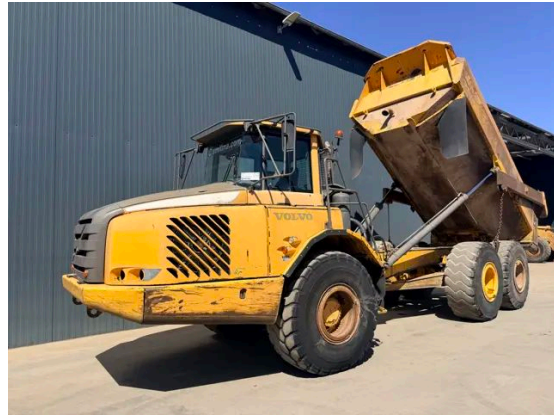
The Volvo A25E is a robust articulated dumper designed for tough construction environments. It features a Volvo D9B engine with an impressive power output of 224kW and complies with Emission Stage 3A. The machine comes equipped with a 6x6 drive configuration, ensuring excellent traction on all terrains. The ergonomic EROPS cabin is fitted with air conditioning for operator comfort. Additional enhancements include a large tailgate, body extensions, backup camera and alarm, beacon, and an AM/FM radio. The dumper has accrued genuine hours and remains in good, clean condition, ready for any heavy-duty task.
