INSPECTION REPORT

WIRTGEN W100Fi

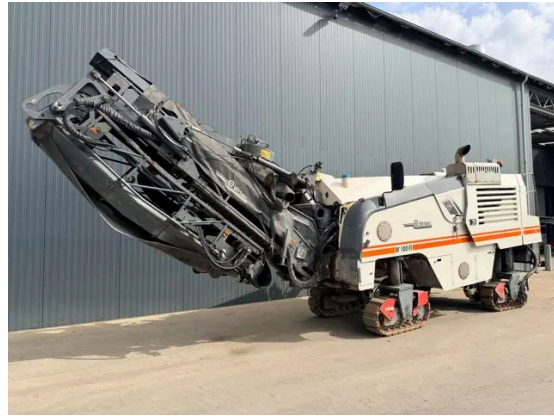
The Wirtgen W100Fi is a versatile cold milling machine from 2014, featuring a robust Cummins QSL9 300 engine with a power output of 224kW. It complies with both EPA and CE regulations, ensuring environmental responsibility. The machine is designed for efficiency, with a milling drum width of 1200mm and a milling depth up to 320mm. It's equipped with a standard milling drum, a front conveyor belt, and hydraulic lifting side plates for enhanced functionality. The backup alarm adds an extra layer of safety, and the machine is in good and clean condition, having completed 5186 genuine hours of operation.
