## KOMATSU HM400-3

### Description

# INSPECTION REPORT

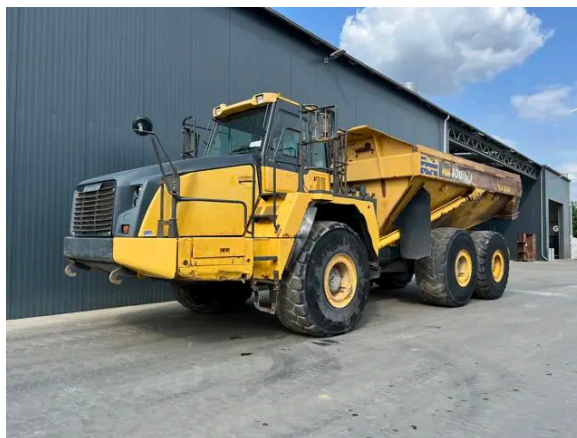
Komatsu HM400-3, Engine Komatsu , SAA6D140E-6, 353 kW, EPA, CE, Air conditioning, 6x6, Erops cabin, 29.5R25, Retarder, Body extensions, Backup camera, In good and clean condition.

Year	2012
Hours	16264
Weight	33740 kg
Serial number	KMTHM012L29003167
Reference	207255
