INSPECTION REPORT

CATERPILLAR 336F L - NEW CHAINS AND TRACKS

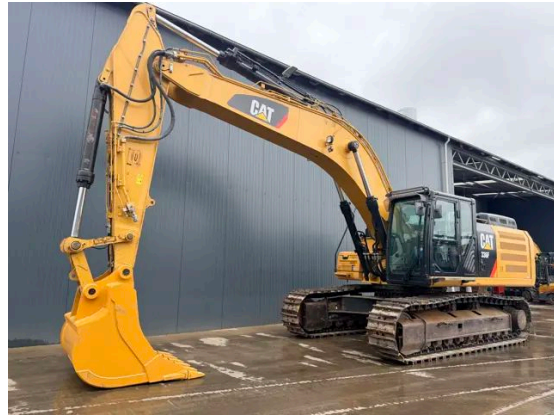
The Caterpillar 336F L is a robust excavator featuring a new set of chains and tracks. Powered by a Caterpillar C9.3 engine, it offers a powerful 234kW and complies with EPA and CE standards. This machine is equipped with modern amenities such as air conditioning and a backup camera. It has a mono boom with a length of 6.5m and a stick length of 3.2m. The digging bucket, measuring 1.4m in width, comes with new teeth. Piped for hammer and shear operation, and equipped with burst valves on lift and stick cylinders, it is in certified good condition with Caterpillar confirming the hours of use. Weighing 57,700 kg and originating from Japan, this 2017 model is a reliable choice for demanding tasks.
