## AMMANN ARS130 HX

### Description

# INSPECTION REPORT

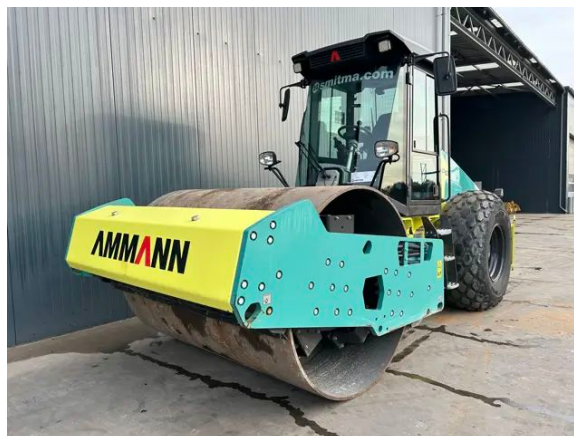
Ammann, Deutz, TCD 3,9 L4, 100kW, EPA, CE, Erops cabin, 23.1 - 26, Frequency meter, Speed meter, Air conditioning, Backup alarm, AM/FM radio, Genuine hours, In very good and very clean condition.
