## INSPECTION REPORT

### CATERPILLAR 120M - CE

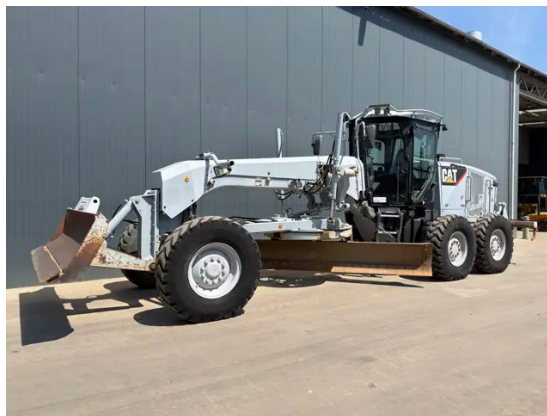
The Caterpillar 120M motor grader features a robust C6.6 engine delivering 114 kW of power. This model includes an air conditioning system, hydraulic tip control, and a front blade, making it ideal for various grading tasks. Fitted with a backup camera for enhanced safety, the machine is also GPS-ready. It stands out with its differential unlock capability, AM/FM radio, and a ripping attachment. Its center blade spans 3.66 meters, providing broad coverage for larger areas. With 14,578 hours of certified operation, it remains in pristine and clean condition, reflecting Caterpillar's high standards.
