CATERPILLAR CS76 XT

Description

Caterpillar C76, Caterpillar, C6.6, 129kW, EPA, Erops cabin, 23.1-26, Air conditioning, Hours certified by Caterpillar, In very good and clean condition.

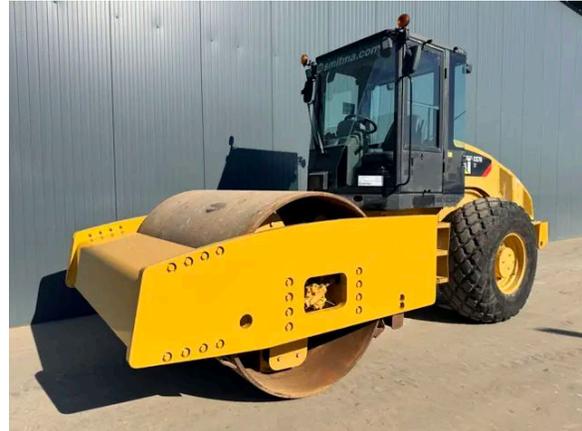
Year	2008
Hours	5451
Weight	18.800 kg
Serial number	CAT0CS76JJCS00116
Reference	211474
